## Zone control bulletin

### AC Module Mitsubishi Electric

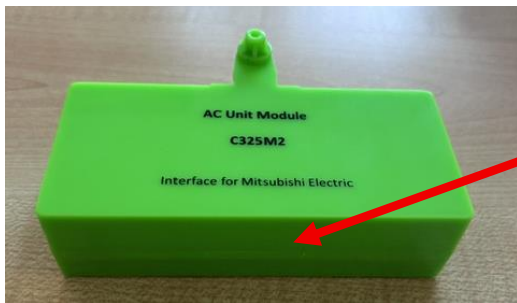
- The RED LED on the rear of the C325M2 will blink intermittently.
- The Nova tablet will alternate between “No Comms” and “OK” in the AC Unit Status.

This behaviour indicates intermittent communication loss between the C325M2 and the ME AC unit.

Visual indicator: A blinking RED LED on the back of the module

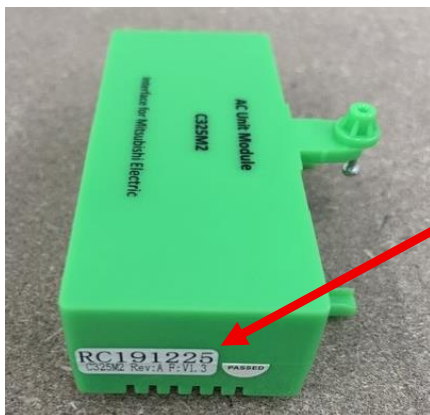
- Unplug the C325M2 module.
- Look through the front of the casing.
- A small jumper will be visible on the PCB if the module is from the defective batch.

This only affects C325M2 modules and production batch RC191225.

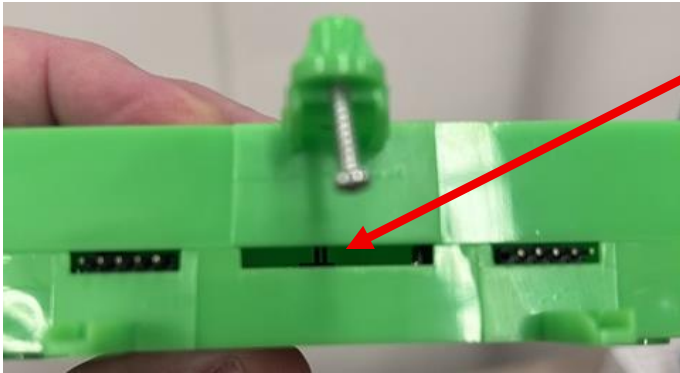
Look through the front of the casing. A small jumper will be visible on the PCB if the module is from the defective batch.
